## Tektronix 515A - 5-inch Service Oscilloscope

## Servicing the 515A

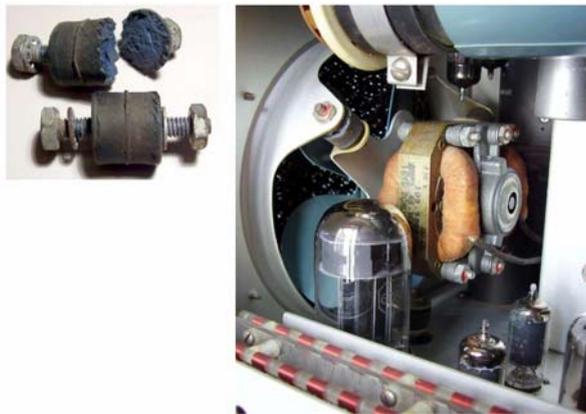
The equipment had suffered a severe stroke in the rear cooling filter. As result, two out of the three fan rubber spacers were ripped off and the fan itself was hanging inside the cabinet from the third spacer. It was necessary to remove the entire fan cage, unscrew the rubber mounts, glue them with flexible cyanoacrylate and then reassemble the fan. Rotor bushings were cleaned from dried grease and lubricated. Careful aligning of the bent propeller blades was then performed. Cleaning and straightening of the bent air filter completed the job in this section.

**Left, a broken rubber spacer and a good one. Right, the fan just serviced.**

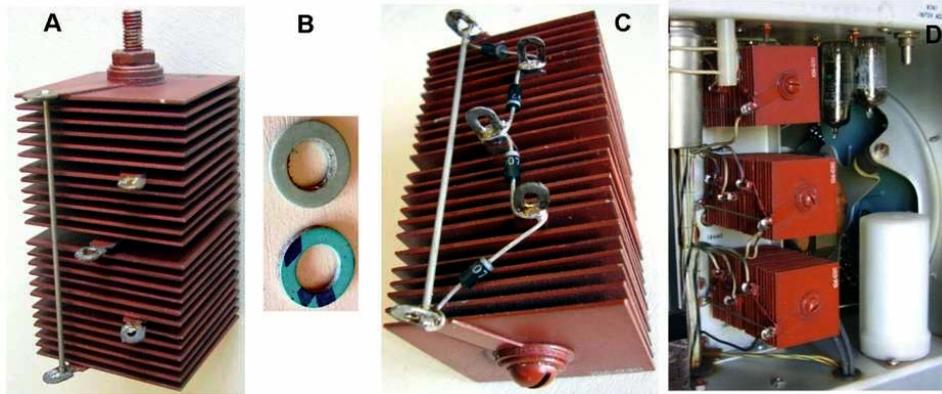
**Keep them alive!**

Starting from left: A) Original selenium rectifier. B) 1/2 “ fiber washers for flexible water hoses are approximately the same size of the metal washers used between the plates in the stacks. C) Once mounted the insulating fiber washers into the selenium stacks, silicon diodes were soldered to the terminal lugs. D) After a lacquer coating, selenium rectifiers are back again, with their original look.

1) The three selenium bridge rectifiers were removed and modified, replacing one metal washer per section with fiber ones, in order to open all the selenium diodes. Silicon diodes were then added in parallel to the old stacks. A finishing coating with a red nail lacquer completed the job.

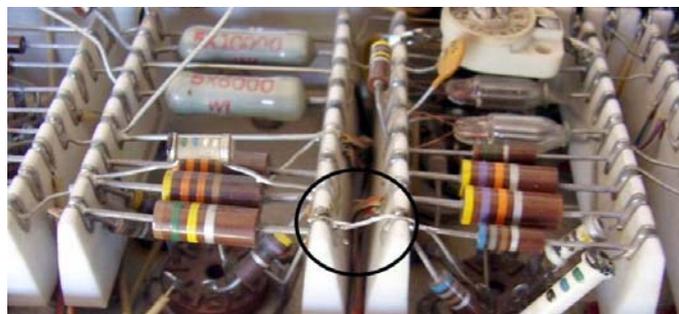
Once fixed the power supply, a small dot appeared on the screen, but time base controls were inoperative. For this section the schematic diagram found on the Web was quite different from the actual circuit. Anyway, after several measurements along the chain and after a careful visual inspection with a magnifying glass, a cut wire was found between the Schmitt multivibrator of the trigger section and the time-base Miller integrator. I would like to know the guy who did this job!

The circle indicates the wire jumper that had been cut, insulating the time-base integrator from the trigger circuitry.

Once replaced the jumper, the oscilloscope returned to life with a sharp trace.
