Tektronix 515A - 5-inch Service Oscilloscope

Servicing the 515A

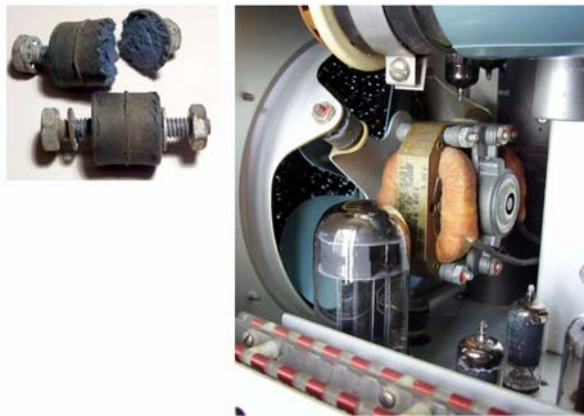
The equipment had suffered a severe stroke in the rear cooling filter. As result, two out of the three fan rubber spacers were ripped off and the fan itself was hanging inside the cabinet from the third spacer. It was necessary to remove the entire fan cage, unscrew the rubber mounts, glue them with flexible cyanoacrylate and then reassemble the fan. Rotor bushings were cleaned from dried grease and lubricated. Careful aligning of the bent propeller blades was then performed. Cleaning and straightening of the bent air filter completed the job in this section.

Left, a broken rubber spacer and a good one. Right, the fan just serviced.

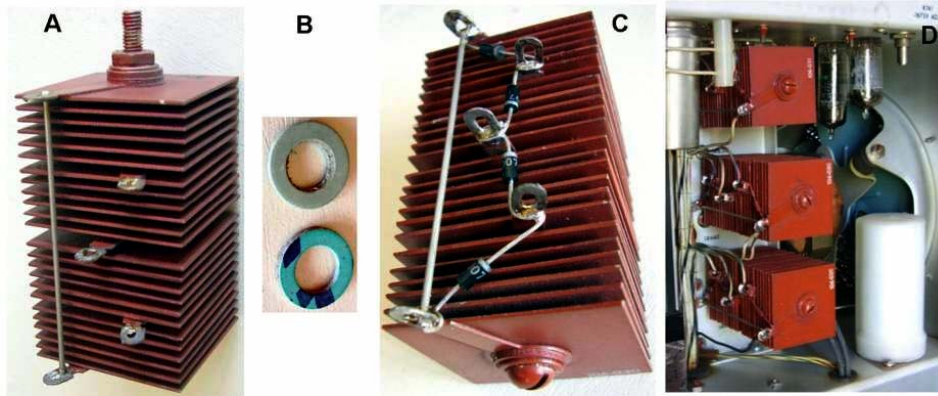
Starting from left: A) Original selenium rectifier. B) 1/2 “ fiber washers for flexible water hoses are approximately the same size of the metal washers used between the plates in the stacks. C) Once mounted the insulating fiber washers into the selenium stacks, silicon diodes were soldered to the terminal lugs. D) After a lacquer coating, selenium rectifiers are back again, with their original look.

- 1) The three selenium bridge rectifiers were removed and modified, replacing one metal washer per section with fiber ones, in order to open all the selenium diodes. Silicon diodes were then added in parallel to the old stacks. A finishing coating with a red nail lacquer completed the job.

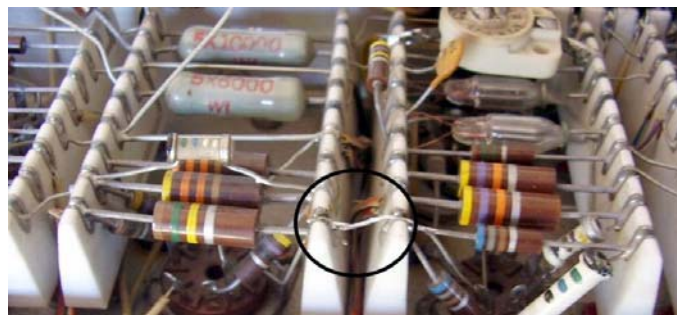
Once fixed the power supply, a small dot appeared on the screen, but time base controls were inoperative. For this section the schematic diagram found on the Web was quite different from the actual circuit. Anyway, after several measurements along the chain and after a careful visual inspection with a magnifying glass, a cut wire was found between the Schmitt multivibrator of the trigger section and the time-base Miller integrator. I would like to know the guy who did this job!

The circle indicates the wire jumper that had been cut, insulating the time-base integrator from the trigger circuitry.

Once replaced the jumper, the oscilloscope returned to life with a sharp trace.
