Tektronix 310A - 3-inch Service Oscilloscope

Electrical service of the 310A, S/N 012561.

Electrical service of the 310A, S/N 012572.

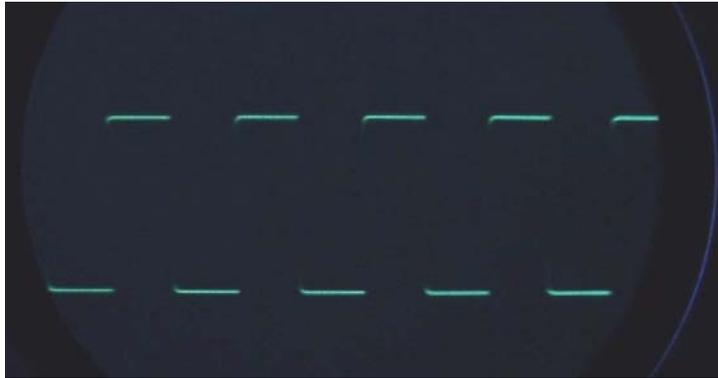
The oscilloscope is now fully operating, with a sharp and brilliant trace. I took the picture below, removing the plexiglass graticule to better focus the camera.

Voltages were quite close to their nominal values, with the exception of the unregulated 400V. I replaced the dried filter capacitor C660, adjusting the -150 volt to the exact value. All the voltages returned to their specified values. A regular flickering of the neon diode B163 in the time base circuits indicated that this section was operating correctly. Using the right cautions and my old AVOMeter 8 MKIV, the one with 2500V f.s. range, I started to check the high voltage supply section. Here I found that both brightness and focus controls were faulty. A short between the cursor and one of the side connections could be measured. Some oxide grown between the body metal plate and the rivets connecting the resistive element to the terminal lugs was at the origin of the problem. The faulty potentiometers were replaced using the good ones removed from the third unit.

The trace appeared, but after few minutes focus and brightness became to drift considerably, while the absolute value of high voltage was rapidly decreasing under 1600 volts. The voltage on the screen grid of the oscillator V704, a 6AQ5, was at its maximum value, indicating that the control loop was operating fine. The new

problem was fixed in a faulty C705 resonating capacitor across the primary winding of the HV transformer. The capacitor was leaky, probably punctured, and the leakage increased when warm, after few minutes of operation.

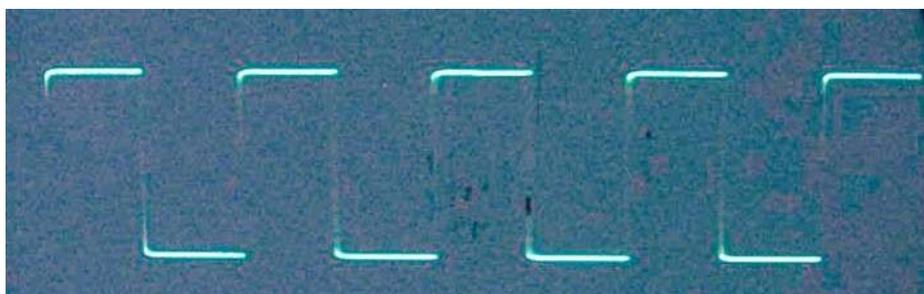
Moving the trace position controls, a sort of unfocused spot was visible on the screen, but horizontal deflection was inoperative. A check of the supply voltages returned a quite low value, around 85 volts, on the regulated +100 V supply line. The filter aluminum capacitor C630 was found dried and was then replaced. Even the +300V was somewhat low, around 285 volts. The problem was cleared replacing the 12B4 series pass regulator tube, V663. Once fixed the problems in the power supply section, the time base returned to its operation, even if the trace appeared considerably out of focus. The value of the accelerating voltage was found around -1550 volts and a small adjustment of the trimmer R741, H.V. Adj, was required to return this voltage to its nominal value, -1675 volts. The trace is now sharp and brilliant as in the picture below.
