## Tektronix 310A - 3-inch Service Oscilloscope

### **Electrical service of the 310A, S/N 012561.**

### **Electrical service of the 310A, S/N 012572.**

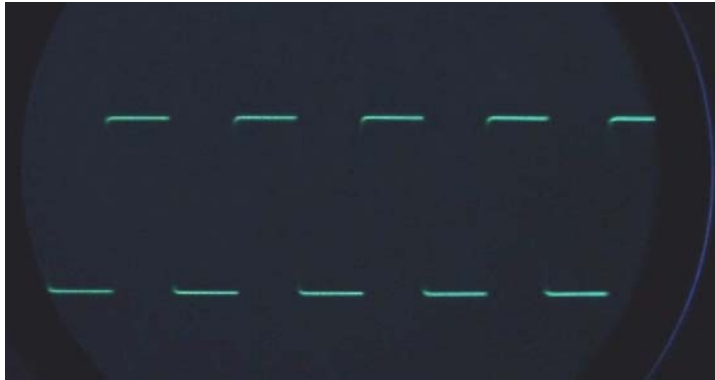
The oscilloscope is now fully operating, with a sharp and brilliant trace. I took the picture below, removing the plexiglass graticule to better focus the camera.

Voltages were quite close to their nominal values, with the exception of the unregulated 400V. I replaced the dried filter capacitor C660, adjusting the -150 volt to the exact value. All the voltages went within their specified values. A regular flickering of the neon diode B163 in the time base circuits indicated that this section was operating correctly. Using the right cautions and my old AVOMeter 8 MKIV, the one with 2500V f.s. range, I started to check the high voltage supply section. Here I found that the brightness and the focus controls were both faulty. A short between the cursor and one of the side connections could be measured. Some oxide grown between the base metal plate and the rivets connecting the resistive element to the terminal lugs was at the origin of the problem. The problem was cleared replacing the two potentiometers with the good ones taken from the third unit.

The trace appeared, but after few minutes focus and brightness became to drift considerably, while the absolute value of high voltage was rapidly decreasing under 1600 volts. The voltage on the screen grid of the oscillator V704, a 6AQ5, was at its maximum value, indicating that the control loop was operating fine. The new

problem was fixed in a faulty C705 resonating capacitor across the primary winding of the HV transformer. The capacitor was leaky, probably punctured, and the leakage increased when warm, after few minutes of operation.
