## Tektronix 515A - 5-inch Service Oscilloscope

## Servicing the 515A

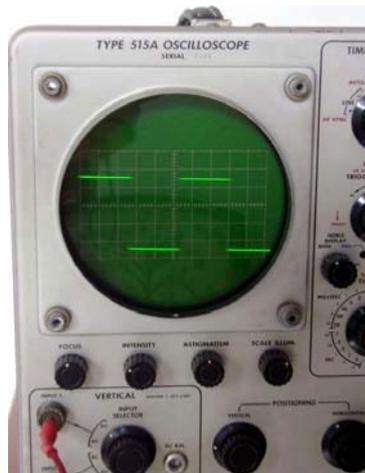
Once replaced the jumper, the oscilloscope returned to life with a sharp trace.

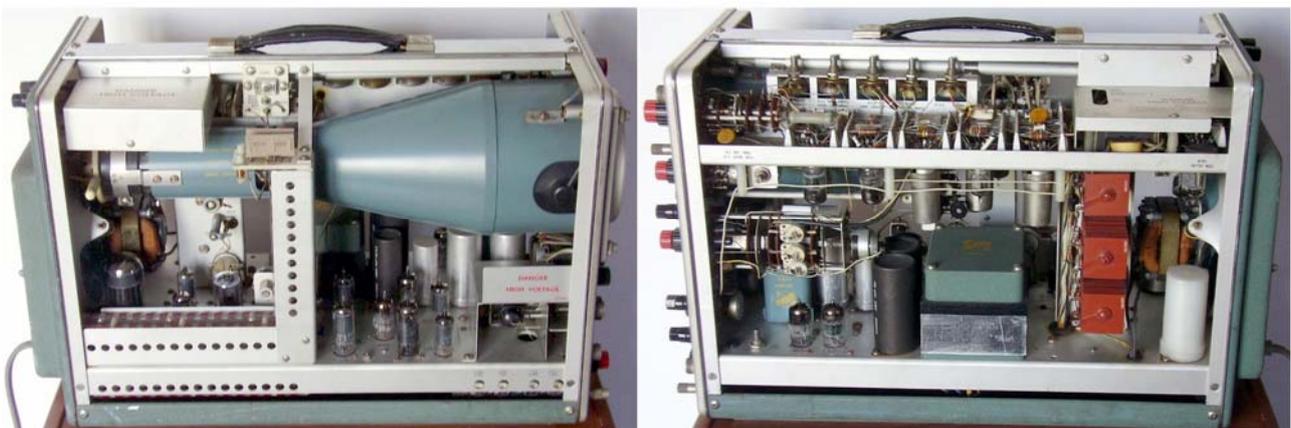
As in many Tek scopes, the carrying handle was frayed. I spent a lot of time to find suitable materials, black leatherette and waxed white sewing cord, and more time to build a new handle around the old steel core. The result was quite poor, since the cord tension was not uniform.
