Tektronix 515A - 5-inch Service Oscilloscope

Servicing the 515A

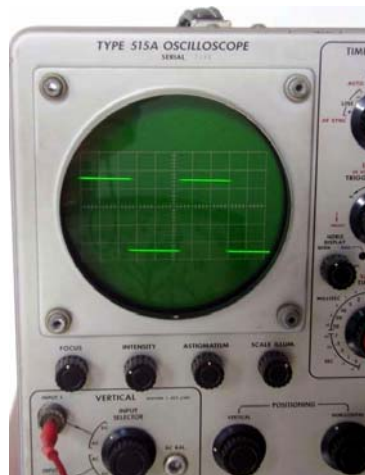
Once replaced the jumper, the oscilloscope returned to life with a sharp trace.

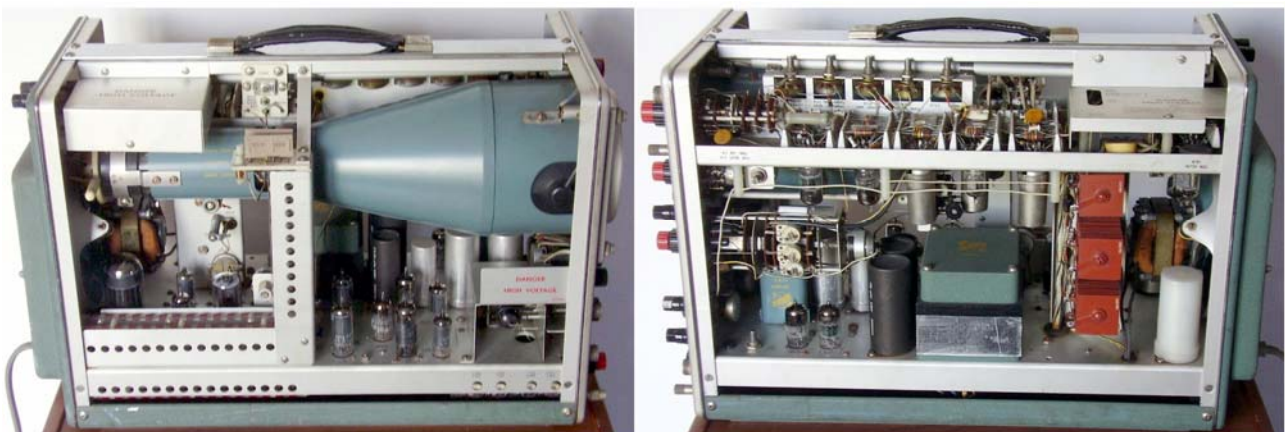
As in many Tek scopes, the carrying handle was frayed. I spent a lot of time to find suitable materials, black leatherette and waxed white sewing cord, and more time to build a new handle around the old steel core. The result was quite poor, since the cord tension was not uniform.

Today this little brother of the huge mainframes lives again, showing very stable operation within its original specs.
